M2 Junction 1 South Eastbound Merge Safety Review

Document no: B2432000-MedwayLP-M2J1-SR
Revision: 1

Medway Local Plan
21 October 2025

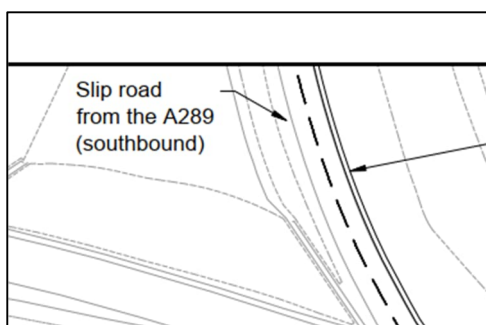
2.1.1 Problem

Location: Upstream of, and at the commencement of the two-lane section on the interchange link.

Summary: Unclear tie-ins could give rise to driver confusion, inappropriate lane changes, and an increased potential for side-swipe/ lane change collisions.

Description: There is currently a single exit lane at the A289 diverge, but two traffic lanes are shown on the interchange link on the drawing supplied for review. It is unclear to the review team how the single lane diverge will flare to become two lanes on the interchange link and the drawing does not clearly illustrate how the space to accommodate the additional traffic lane will be provided. The flare is also located on a bend, and so the change in layout may not be obvious to approaching drivers.

Failure to provide a suitable transition which is clear to approaching drivers may result in sudden lane changes, and an increased potential for side swipe collisions.

Recommendation: Clearly show on design drawings how tie-ins with the existing layout will be accommodated, and provide clear guidance, adequate forward visibility and a smooth transition from one to two lanes in line with guidance and standards, at the entry to the interchange link.

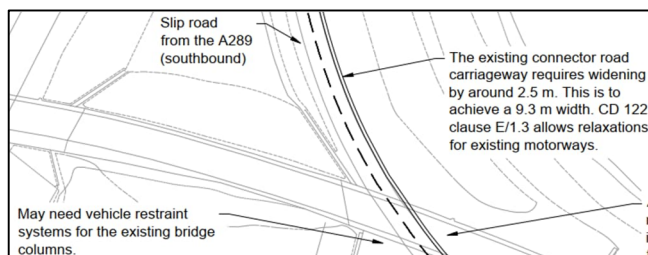
2.1.3 Problem

Location: Nearside verge of the proposed two-lane interchange link, in the vicinity of the A2 bridge.

Summary: Proximity of the realigned traffic lanes to the unprotected bridge structure could increase the potential for bridge strikes, structural damage, and increased severity of injuries in the event of a collision.

Description: The drawing provided appears to show widening to the nearside of the existing interchange link to accommodate an additional traffic lane and this includes the area where the A2 passes overhead on a bridge structure.

The review team have the following concerns:

- Widening will result in the live carriageway being located closer to the existing unprotected bridge columns than at present, which may increase the potential for an errant vehicle to strike the bridge support at speed, resulting in higher severity of injury for casualties and potential damage to the bridge structure
- Although the carriageway follows a left hand bend, the provision of an additional lane here could increase the likelihood of lane changes and the potential for side swipe collisions resulting in a vehicle leaving the carriageway. This in turn could increase the potential for striking the bridge supports.

It is noted that the drawing provided includes an annotation which advises of the possible need for a vehicle restraint system (VRS) here to protect the existing bridge supports.

Recommendation: Provide appropriate levels of VRS in the vicinity of the bridge supports to protect vehicle occupants and the structure in the event of a vehicle leaving the carriageway here.

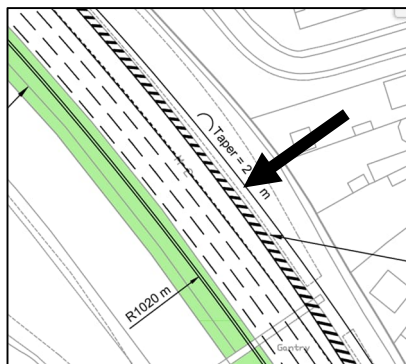
2.1.5 Problem

Location: Nearside verge within the J1 south eastbound merge, a short distance upstream of the 1/2 mile gantry for Junction 2.

Summary: Location of Emergency Roadside Telephone (ERT) within the merge lane following changes to the merge layout may increase the potential for high speed rear end shunt collisions involving broken down vehicles and vehicles merging onto the M2 mainline.

Description: There is currently an ERT located upstream of the M2 J2 1/2 mile gantry, set behind VRS at the back of the existing hard shoulder (image 1, below). Following implementation of the proposed merge layout changes, this ERT will be located adjacent to a hatched area (too narrow for a hard shoulder) towards the end of the nearside merge lane (image 2).

The review team is concerned that an ERT located here following completion of the works may encourage drivers to stop in what may no longer be a relative place of safety, due to high speed merging traffic, and due to provision of insufficient space to accommodate a vehicle off the carriageway whilst someone uses the ERT. Retaining this telephone could increase the potential for high speed rear end shunt collisions involving vehicles merging with the M2 mainline, putting vehicle occupants at risk.

The proximity of the 1/2 mile gantry may also result in drivers failing to identify a stricken vehicle in the lane ahead, as they focus attention on the sign information instead, which could result in late braking and higher speed collisions. See also Problem 2.1.6.

Recommendation: Provide an ERT at a location which can accommodate stranded vehicles safely, giving consideration to the upstream and downstream spacing of these roadside facilities.

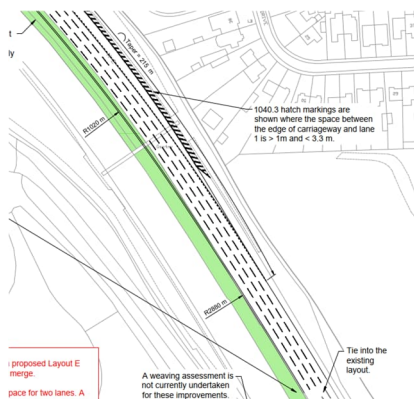
2.1.7 Problem

Location: South eastbound M2 mainline, between the end of the nearside merge lane and the start of the dedicated exit lane for M2 Junction 2.

Summary: Failure to provide sufficient weaving distance between the end of the J1 merge and the start of the J2 diverge may increase the potential for last minute lane changes and side swipe collisions on the approach to the J2 exit.

Description: The proposals include a change to the merge type provided on the south eastbound M2, such that the nearside lane merges with the M2 mainline over 400m further to the south east than currently (all measurements approximated as no CAD drawings were available).

The dedicated lane for the J2 exit commences shortly afterwards, at the next gantry downstream (seen bottom right in the second image above), although it was not possible to measure the distance between the two points accurately as J2 is not shown on the plan provided. The review team is concerned that drivers merging from J1 but not exiting at J2 wishing to change lanes to the right, and mainline traffic wishing to change lanes to the left in preparation for the exit at J2, will both have less time to position themselves in the correct lane than currently, and will be undertaking conflicting manoeuvres. This could increase the potential for last minute lane changes and an increased potential for side swipe and lane change collisions.

It was noted that a single slight injury collision occurred between the J1 merge and J2 diverge in the five years to December 2023, which involved a vehicle moving to the nearside ahead of the diverge.

Recommendation Provide a layout which gives drivers sufficient time, space and advance information to position themselves appropriately in advance of the downstream junction exit.

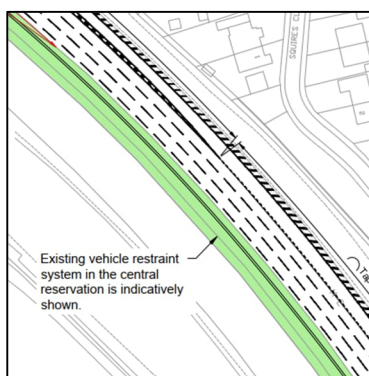
2.1.8 Problem

Location: M2 mainline central reserve throughout the entire area subject to widening under the scheme proposal.

Summary: The effect of locating live traffic closer to VRS and lighting columns located within the central reserve, is unknown, and failure to provide adequate protection could increase the severity of injury in the event of a vehicle leaving the carriageway to the offside.

Description: The existing VRS is shown in the central reserve indicatively. The proposals include carriageway widening into the central reserve by up to 4.2 metres on the south eastbound carriageway, bringing the three lanes of the M2 mainline closer to the existing VRS, and street lighting systems within it. The revised setback, working width of the current VRS, and location of lighting columns relative to the working width, and the condition of the existing VRS are all unknown.

The review team is concerned that following widening and relocation of the running lanes closer to the VRS, the VRS may not perform as expected, and lighting columns may also be at increased risk of being struck, resulting in increased severity of injury for vehicle occupants in the event of a collision.

Current standards for road restraint systems (CD 277 para 2.4) require a risk assessment instead of a full Road Restraint Risk Assessment Process (RRRAP) to be undertaken for central reserves of more than 10m wide. The current, and post-widening, widths of the central reserve are unknown and it is also unknown whether a full RRRAP has already been undertaken.

Recommendation: Provide adequate levels of protection for road users within the central reserve, which also ensures that drivers are not at risk from collisions with lighting columns.

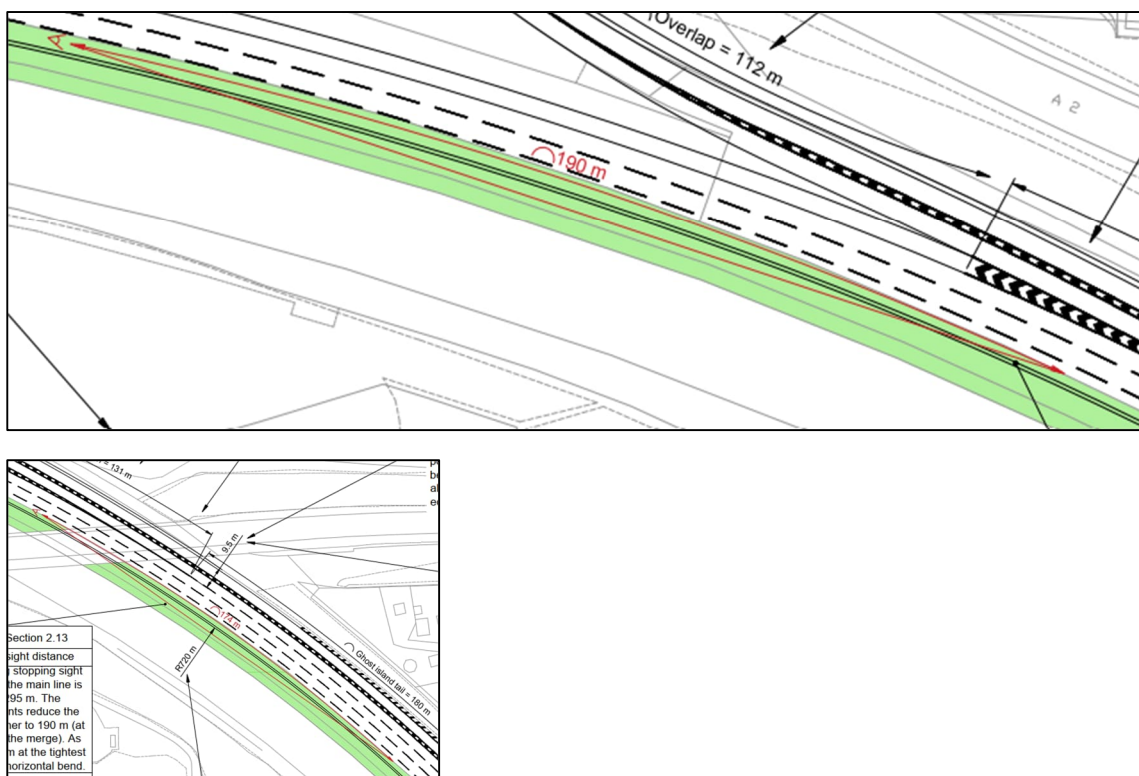
2.1.9 Problem

Location: Offside lane of the realigned south eastbound M2 mainline.

Summary: Reduced stopping sight distance in the offside lane due to VRS or vegetation, may increase the potential for rear end shunt collisions with obscured slow or stationary vehicles or objects in the carriageway ahead.

Description: From plans provided, the tighter radius, and increased proximity to VRS and structures following realignment of the mainline may adversely affect the stopping sight distances for vehicles in the offside lane of the south eastbound carriageway of the M2. The existing VRS is shown indicatively on plans provided, but is likely to be within the visibility envelope, and from a check of © StreetView imagery, vegetation in the central reserve appears overgrown. Drivers may fail to see and react in time to hazards such as slow or stationary vehicles ahead, or objects within the carriageway, which could result in high-speed rear end shunt or other collisions.

Recommendation: Ascertain the location and height of the VRS to understand its impact on sight stopping distances and maintain vegetation to prevent both features impacting forward visibility.

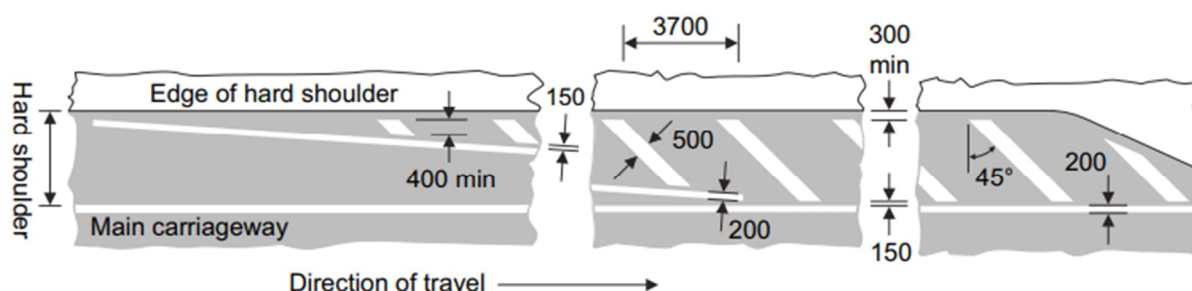
Figure 2-11 Diagram 1040.5 (S11-4-26) End of hard shoulder

Location: Adjacent to the nearside lane towards the south eastern end of the J1 merge.

Summary: Hatching in the nearside hard strip is rotated incorrectly which may cause driver confusion.

Description: Hatched markings to Diagram 1040.5 of the Traffic Signs Regulations and General Directions is shown on plans provided, located in the nearside hard strip upstream of the commencement of the M2 hard shoulder where the width is insufficient to accommodate a hard shoulder. The chevrons are shown rotated incorrectly. An extract from Chapter 5 of the Traffic Signs Manual is shown below.

Recommendation: Provide all road markings in accordance with design guidance and standards to minimise the potential for driver confusion.

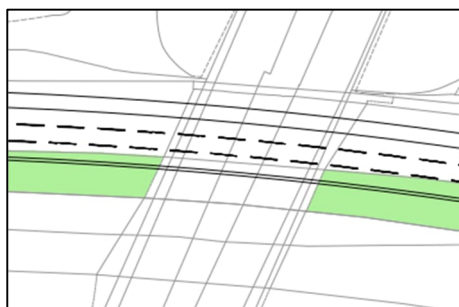
3.1.4 Issue

Location: M2 mainline central reserve adjacent to the bridge deck over the M2 westbound/A289 interchange link.

Summary: Potential hazard from vehicles overrunning area of bridge structure which may not be designed to support them.

Description: The design proposals include carriageway widening into the central reserve by up to 4.2 metres, and include a section where the M2 passes over another road on a bridge structure. In the absence of structural details regarding the bridge, it was not possible to determine whether the widening in the central reserve could be safely accommodated.

Recommendation: Assess the bridge structure to understand whether it can safely accommodate the traffic volumes expected to use the realigned offside lane under the revised M2 layout.
