M2 Junction 1 South Eastbound Merge Safety Review

Document no: B2432000-MedwayLP-M2J1-SR
Revision: 1

Medway Local Plan
21 October 2025

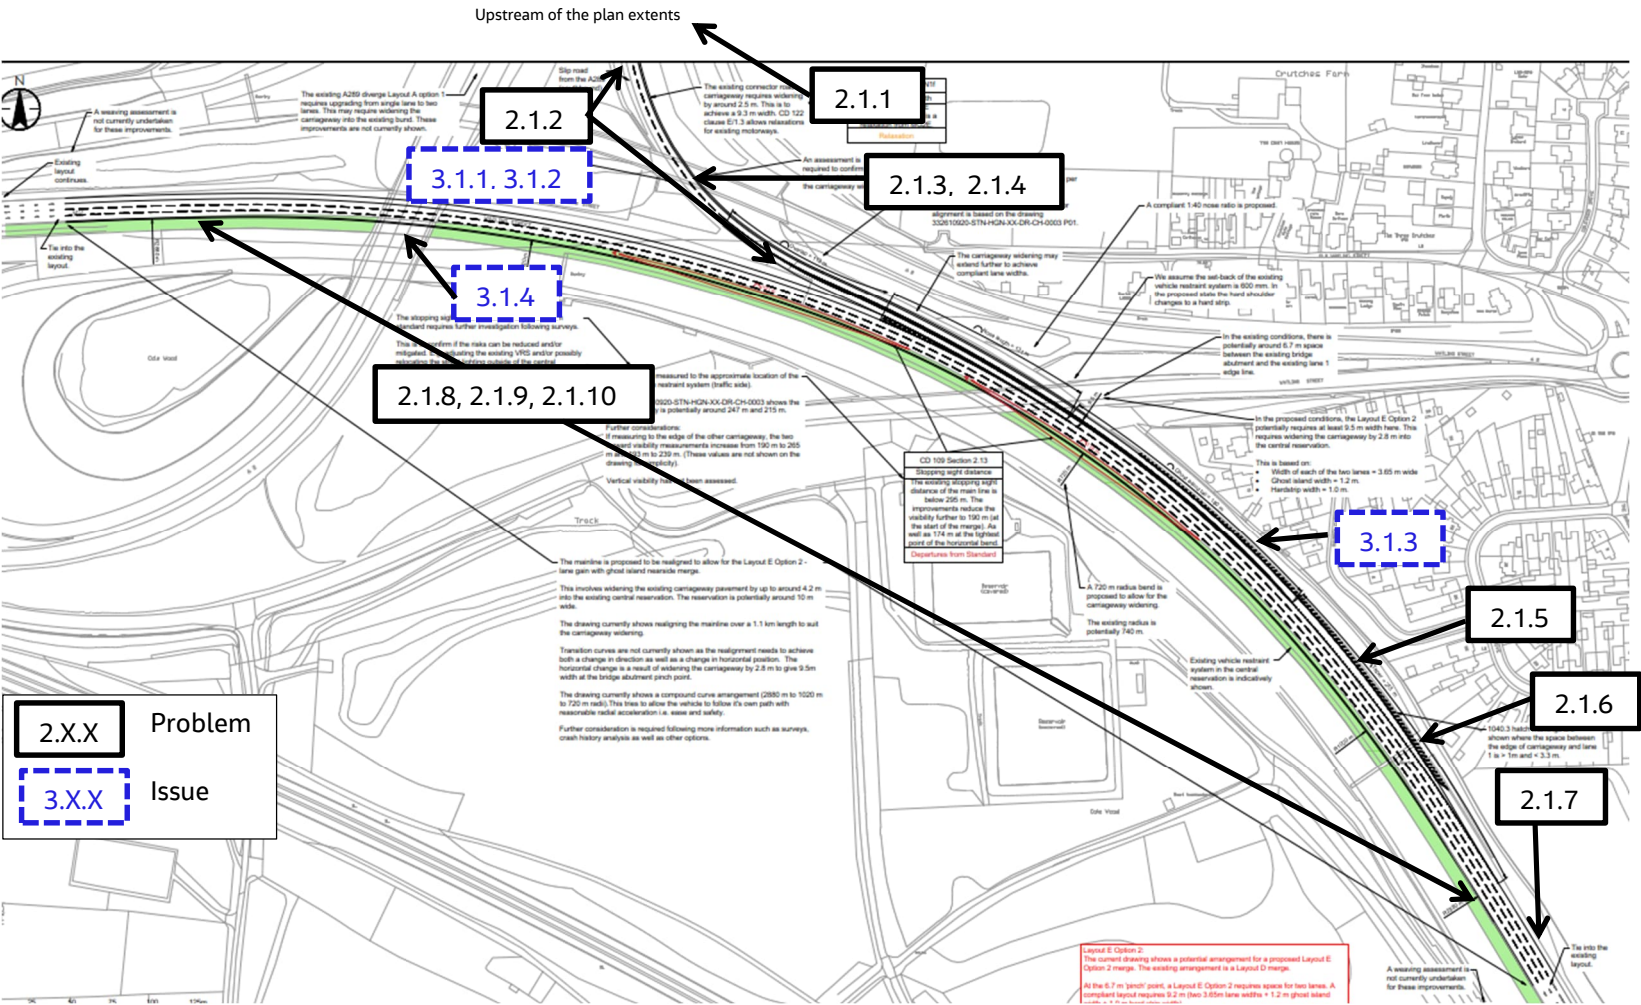
Extract from 332610920-STN-HGN-XX-DR-CH-0004 Rev P01

All Problems are associated with Drawing Number 332610920-STN-HGN-XX-DR-CH-0004 Rev P01. An extract of this drawing can be found in Appendix B.

Failure to provide a suitable transition which is clear to approaching drivers may result in sudden lane changes, and an increased potential for side swipe collisions.

Summary: Failure to adequately illuminate the carriageway post-widening could increase the potential for loss of control or fail to stop collisions during the hours of darkness.

Summary: Proximity of the realigned traffic lanes to the unprotected bridge structure could increase the potential for bridge strikes, structural damage, and increased severity of injuries in the event of a collision.

- Widening will result in the live carriageway being located closer to the existing unprotected bridge columns than at present, which may increase the potential for an errant vehicle to strike the bridge support at speed, resulting in higher severity of injury for casualties and potential damage to the bridge structure
- Although the carriageway follows a left hand bend, the provision of an additional lane here could increase the likelihood of lane changes and the potential for side swipe collisions resulting in a vehicle leaving the carriageway. This in turn could increase the potential for striking the bridge supports.

Description: No information on levels or available headroom was available to the review team at this early design stage, and although the existing carriageway has sufficient clearance, it was noted that the design of the structure appears to taper downwards close to the support pillars.

Summary: Location of Emergency Roadside Telephone (ERT) within the merge lane following changes to the merge layout may increase the potential for high speed rear end shunt collisions involving broken down vehicles and vehicles merging onto the M2 mainline.

Description: There is currently an ERT located upstream of the M2 J2 1/2 mile gantry, set behind VRS at the back of the existing hard shoulder (image 1, below). Following implementation of the proposed merge layout changes, this ERT will be located adjacent to a hatched area (too narrow for a hard shoulder) towards the end of the nearside merge lane (image 2).

The proximity of the 1/2 mile gantry may also result in drivers failing to identify a stricken vehicle in the lane ahead, as they focus attention on the sign information instead, which could result in late braking and higher speed collisions. See also Problem 2.1.6.

Description: Following implementation of the works, the existing 1/2 mile gantry for J2 will be located within the area where traffic will be merging from the interchange link at J1. This may result in merging drivers concentrating on merging rather than on the information provided on the direction signing, which could result in missing the gantry information and a failure to appreciate that the nearside lane will shortly become a dedicated lane for traffic exiting at Junction 2. The next gantry is located 1/4 mile from the exit.

Failure of merging drivers to read and appreciate the direction information provided could increase the potential for last minute lane change manoeuvres downstream, and an increased potential for involvement in side-swipe collisions.

Recommendation: Clearly show on design drawings how tie-ins with the existing layout will be accommodated, and provide clear guidance, adequate forward visibility and a smooth transition from one to two lanes in line with guidance and standards, at the entry to the interchange link.

Recommendation: Check the age, coverage and suitability of the existing lighting provided, and upgrade as necessary to provide adequate lighting across the entire new road surface.

Recommendation: Provide appropriate levels of VRS in the vicinity of the bridge supports to protect vehicle occupants and the structure in the event of a vehicle leaving the carriageway here.

Recommendation: Survey the working height of the structure to understand its vertical constraints and design the carriageway levels accordingly to provide sufficient clearance for all traffic and adequate protection for the bridge structure.

Recommendation: Provide an ERT at a location which can accommodate stranded vehicles safely, giving consideration to the upstream and downstream spacing of these roadside facilities.

Recommendation: Provide additional driver information, located appropriately to give drivers sufficient time to safely read, comprehend and position themselves appropriately, in preparation for the J2 diverge.

Recommendation: Provide adequate drainage within the central reserve, to suit the revised alignment and available space within the central reserve.
